CASE STUDY

SOUTH PUGET SOUND COMMUNITY COLLEGE — COMMISSIONING ADDS VALUE TO NEW BUILDING

Student Union Building

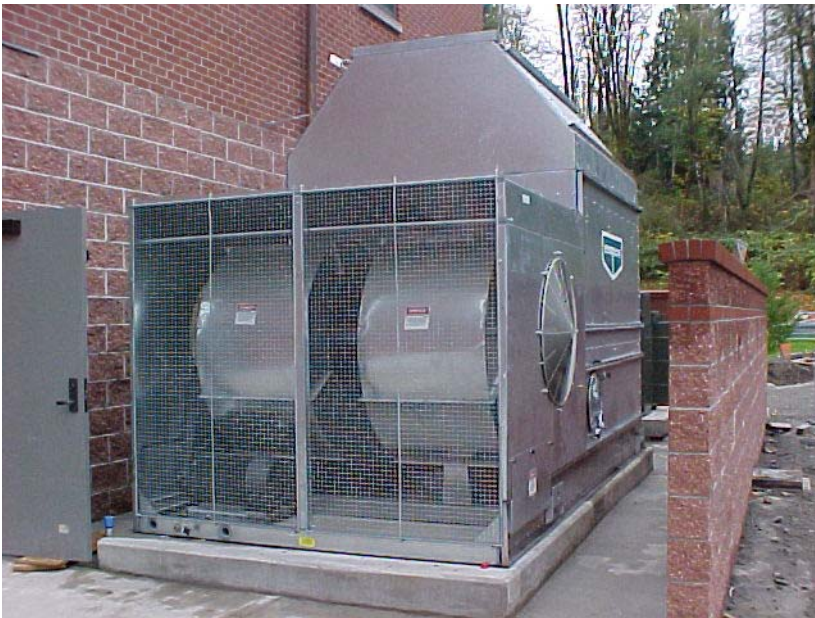
Student Union Building fluid cooler (cooling tower)

- Over-current devices on 8 heat pumps were oversized (code violation).
- The 3-way valve to the fluid cooler was the wrong type and was installed backwards, resulting in no cooling capacity for the system.
